1. REPORT NUMBER	2. GOVT ACCESSION NO.	3. RECIPIENT'S CATALOG NUMBER
4. TITLE (and Subtitle) Phase I Inspection Report Cape Pond Dam Lower Hudson River Basin, Ulster County, NY Inventory No. 265		5. TYPE OF REPORT & PERIOD COVERED Phase I Inspection Report National Dam Safety Program

**LOWER HUDSON RIVER BASIN  
TOWN OF WAWARSING  
ULSTER COUNTY, NEW YORK**

**CAPE POND DAM  
NY - 00265**

**JULY 1981**

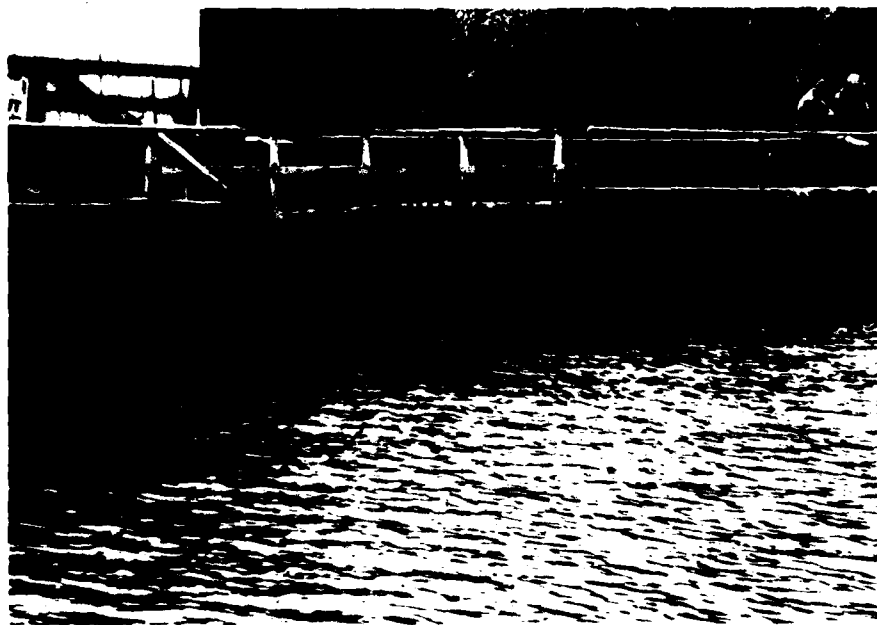
The intake structures to the two slide gates (see Photo A-2A) are formed by concrete and masonry side walls through the upstream rockfill to the gravity section, with wooden bridge decks across the top. The intakes are submerged and therefore the condition of their side walls could not be assessed. At the upstream ends of the intake there are crude wooden trash racks made of 1 inch to 2 inch sticks, with one foot clear openings. Though crude, these intakes are in fairly good condition (see Photo A-7B) and are adequate to perform their functions.

A-7B Intake with trash rack upstream of gate No. 1 - 4/8/81

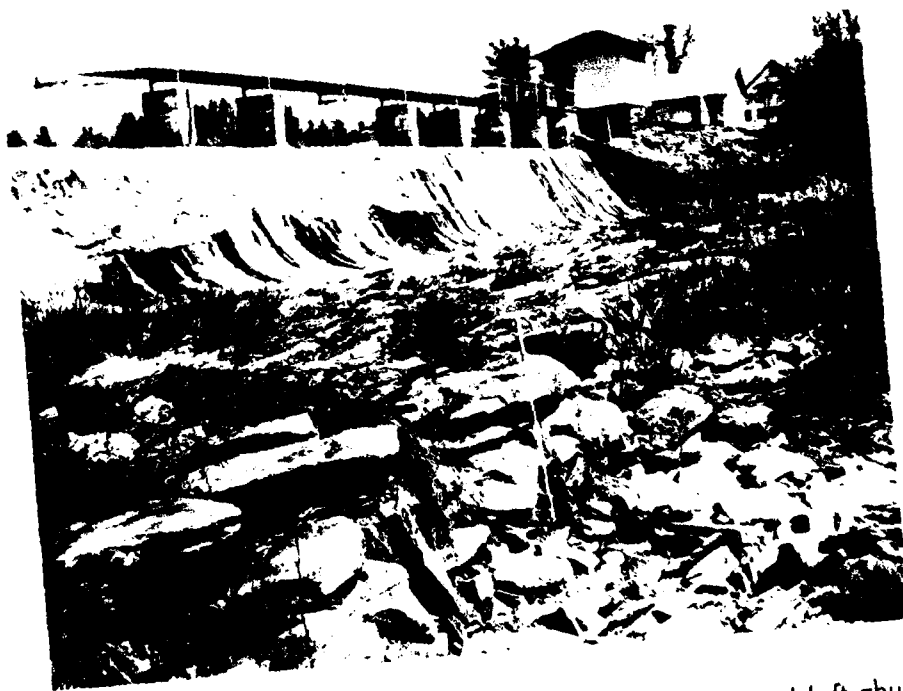
A-9B Spillway and gate houses looking upstream toward left abutment. Note 3-foot drop in foreground at downstream edge of riprap apron - 4/8/81

- 4) Repair the riprap apron downstream of the spillway.
- 5) Repair the deteriorated joint in outlet pipe # 1 to prevent water from leaking out of the pipe into the area of the downstream rockfill.
